Peffery Project Phase 3, 2013-14

Peffery Phase 3:

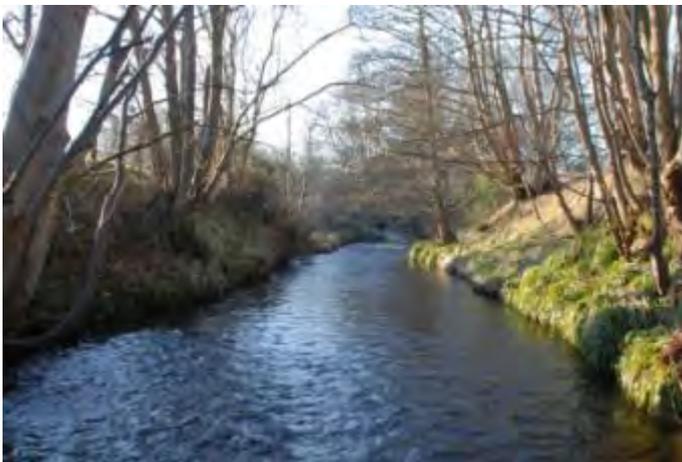
Picture 1; the section between Fodderty House and Railway Bridge. Straight channel constrained within flood banks resulting in a uniform depth with limited in-stream habitat and compacted bed.

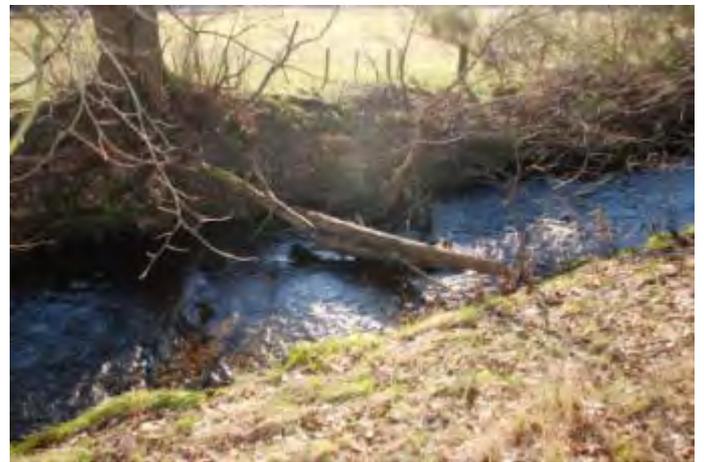
Picture 2; naturally existing LWD upstream of Fodderty Bridge.

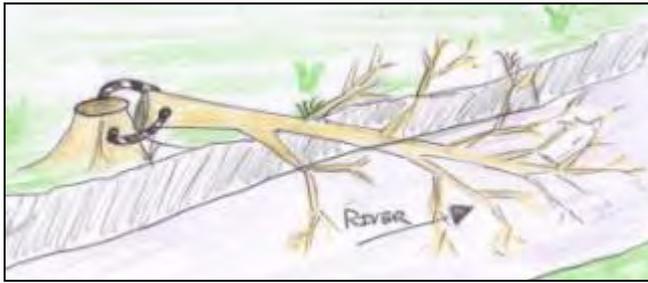
Diagram 1; illustrating how the sycamore trees were felled in situ before being wired to their stumps.

The aim of this project was to improve the natural habitat diversity required to for fish and invertebrates in the river by installing LWD in a way that mimics the natural input of trees from the riparian zone. LWD immediately has an impact on the hydrology and morphology of the river helping to create a diverse range of habitats and to trap fine silt. The Environment Agency Technical Report W185 summarises the benefits of LWD and its use as a management tool. Over 3 days in September a team of Cromarty DSFB Bailiffs, TCV volunteers and MFTI Project Manager, Marcus Walters, felled five sycamores along the 700m section from Fodderty House (NH5133159526) to the Railway Bridge (NH5208559434) (See Appendix 2 - Map). The trees were felled in the riparian zone so as to fall into the river and mimic naturally falling timber (Diagram 1). They were then positioned manually and to ensure they did not cause any flooding or damage

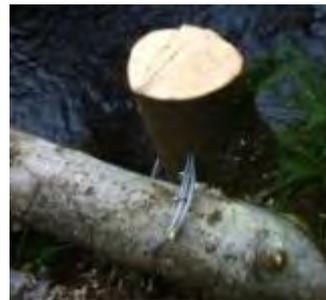
Picture 3; close up of galvanised wire fixing tree to stump

downstream, each one was securely fastened to its stump using 8mm galvanised cable and no trees were installed within 150m of the Railway Bridge. Pictures of the 5 sites before during and 6 weeks post works are shown in Appendix 1.

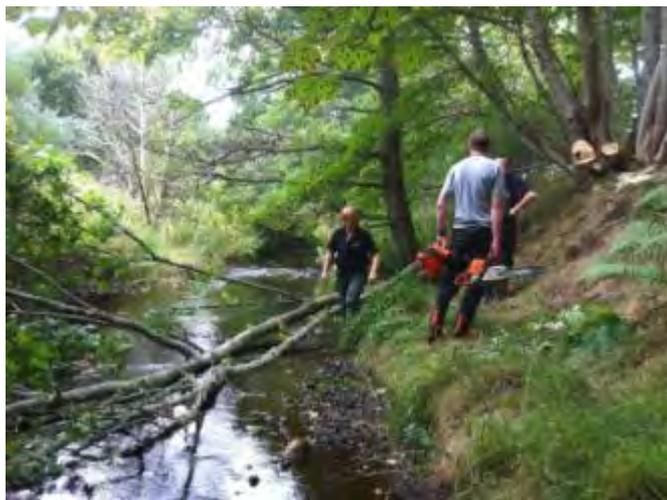
Picture 4; Cromarty DSFB Bailiffs felling sycamores on the bank

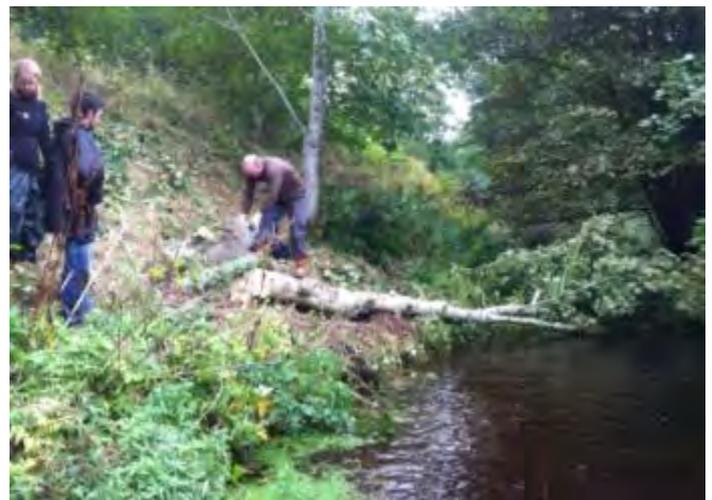
Picture 5; TCV Volunteers positioning trees and fixing in place

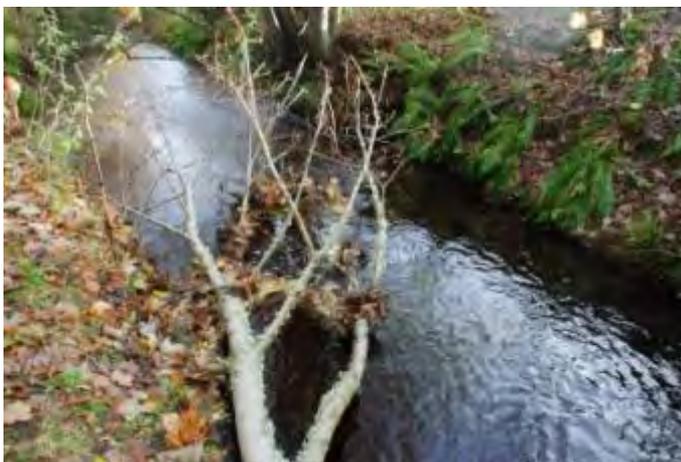
Picture 6; Felled sycamore collecting organic matter and increasing hydraulic effect.

The five felled trees were revisited in mid November, 6 weeks after installation, to check how they were performing. All 5 were still securely fastened to their stumps and although some had swung around with the higher flood flows there was no sign of excessive erosion to adjacent banks. The felled trees were losing their leaves but were doing a good job of trapping smaller organic debris which will build up against the structure and help increase the hydraulic effect. The trees were also beginning to influence flows in the river as they were effectively reducing the channel width and increasing scour at one side while depositing finer materials on the other.

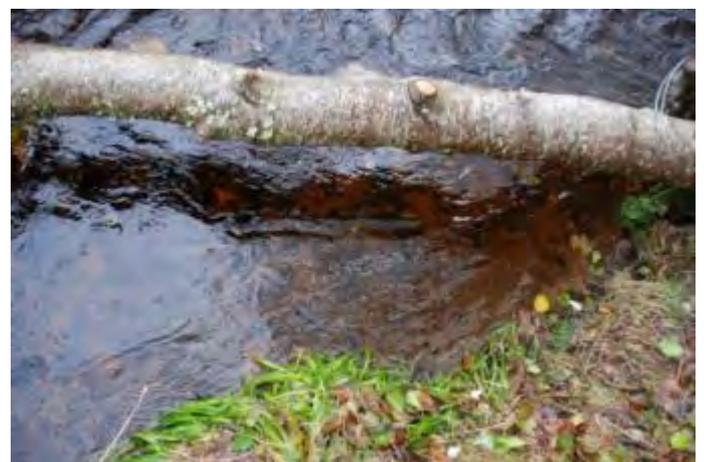
Picture 7; finer sediment beginning to collect behind felled sycamore.

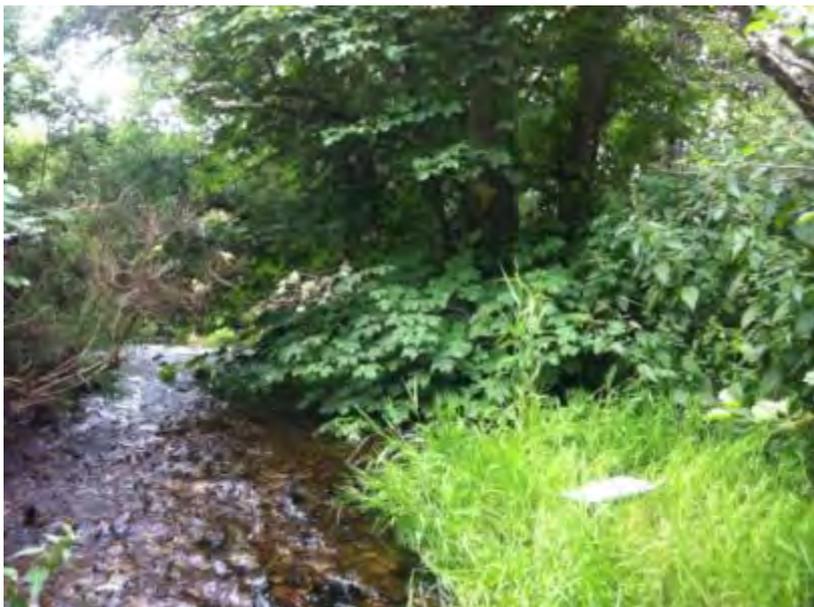
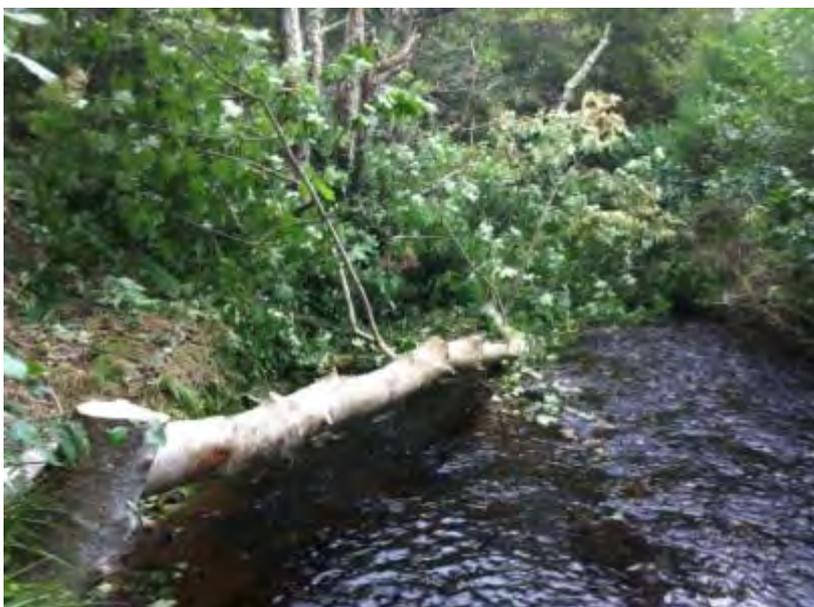
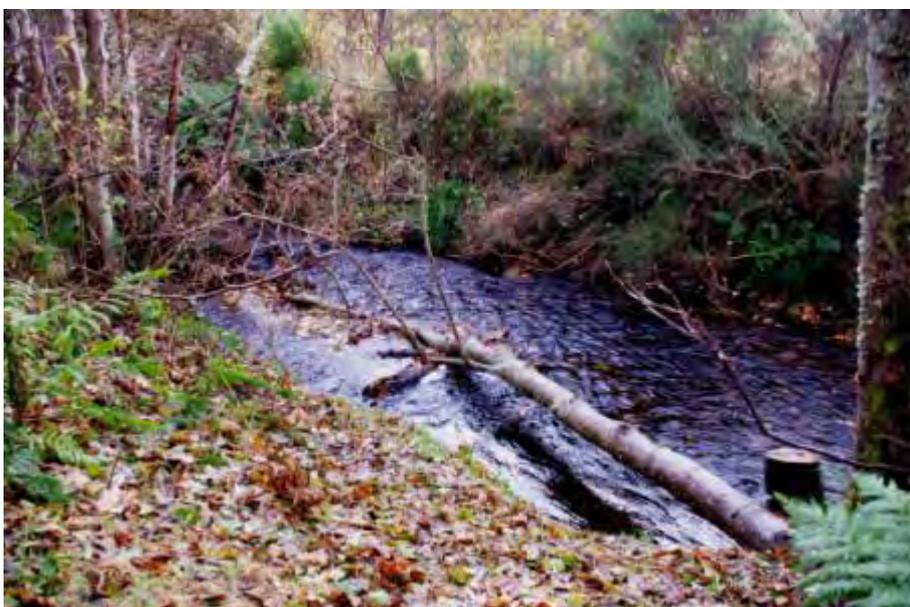
Site P1 (251521, 859497)

Pre works

During works

Post works

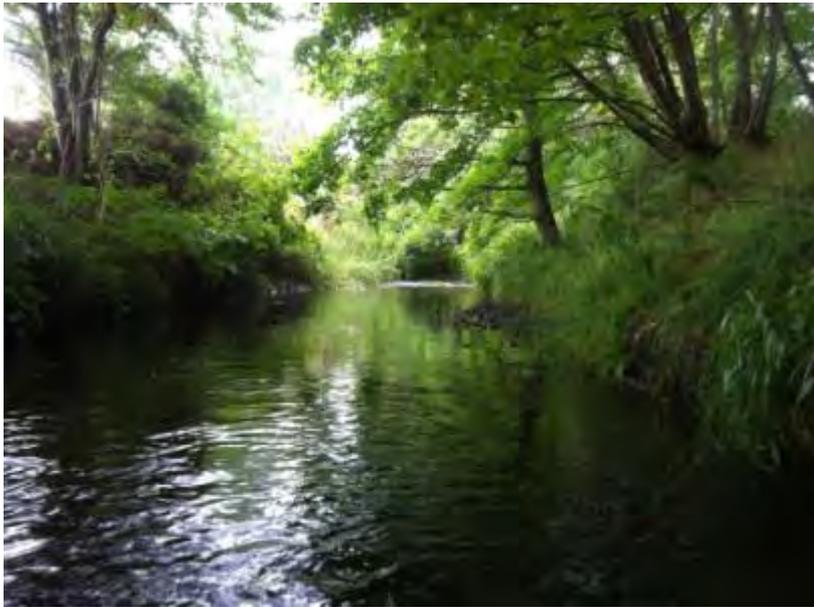
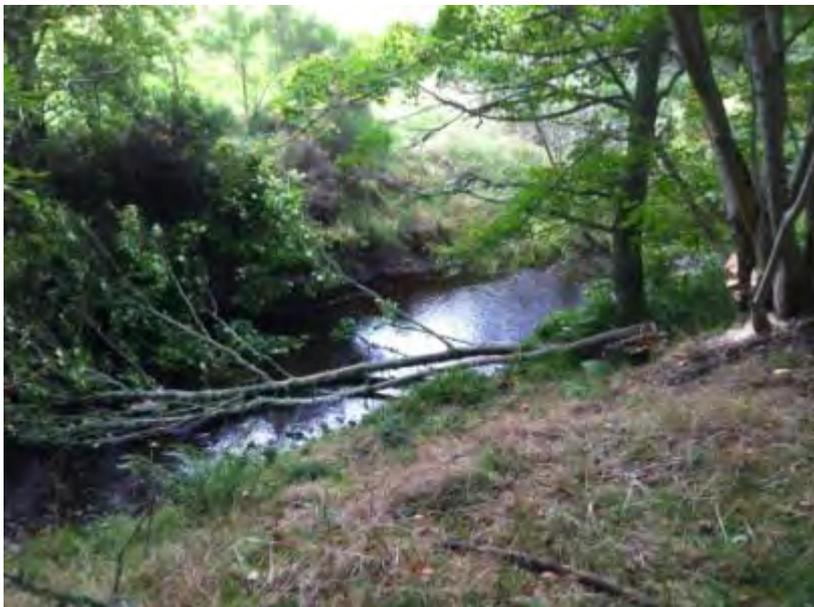
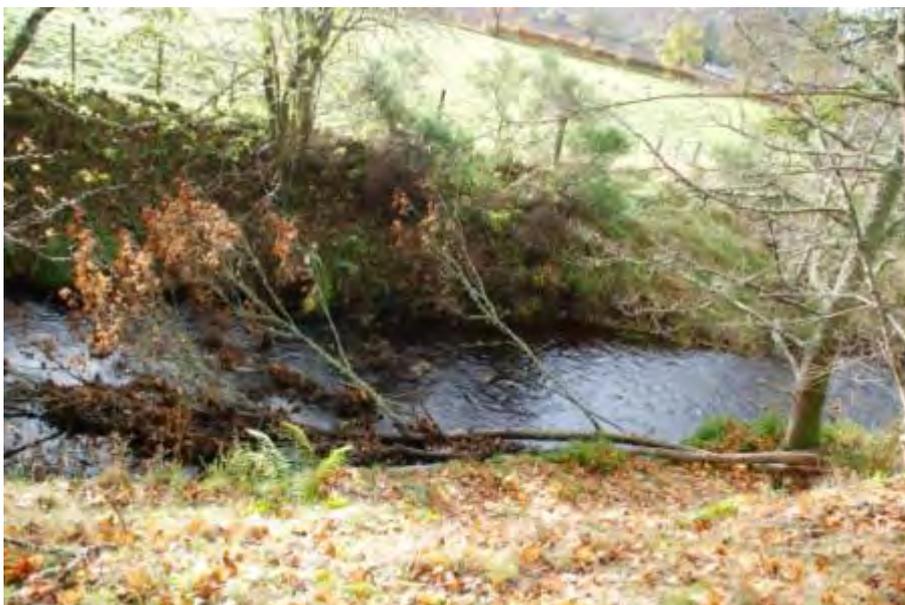
Site P2 (251590, 859471)

Pre works

During works

Post works

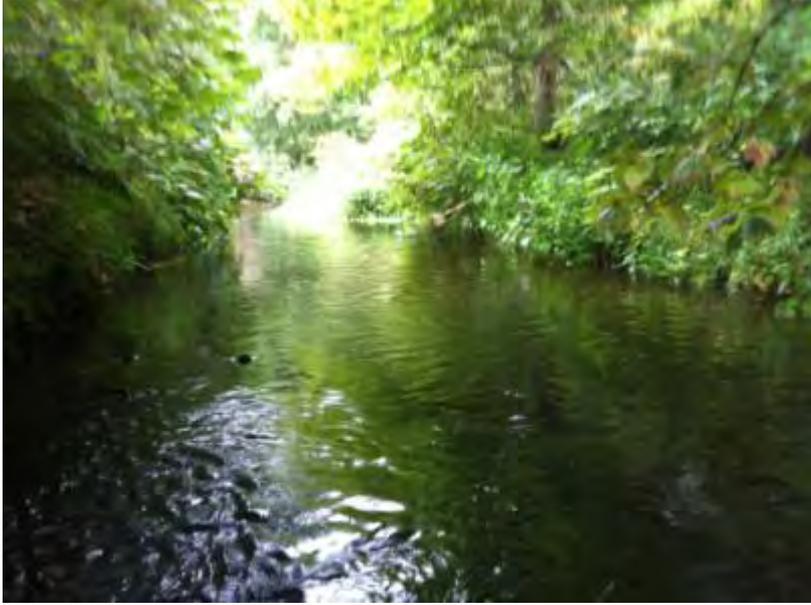
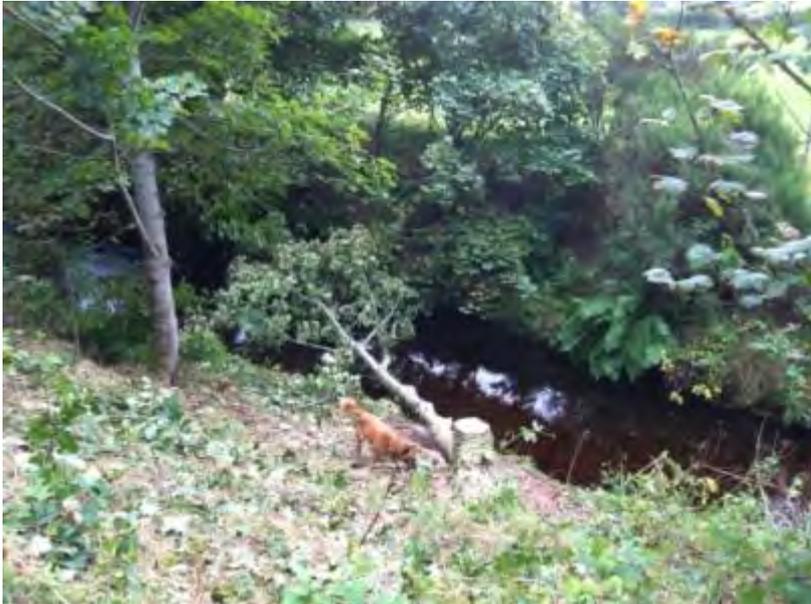
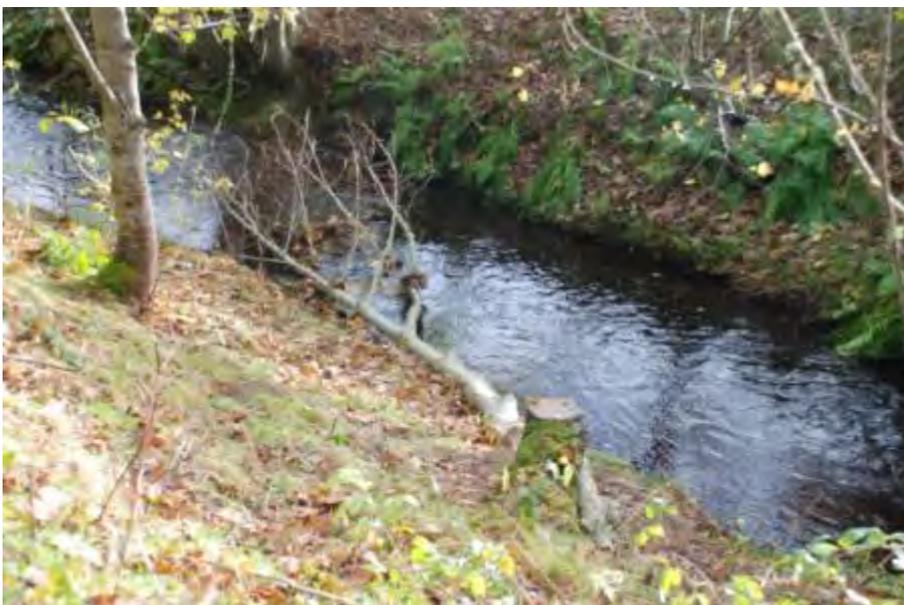
Site P3 (2516679, 859471)

Pre works

During works

Post works

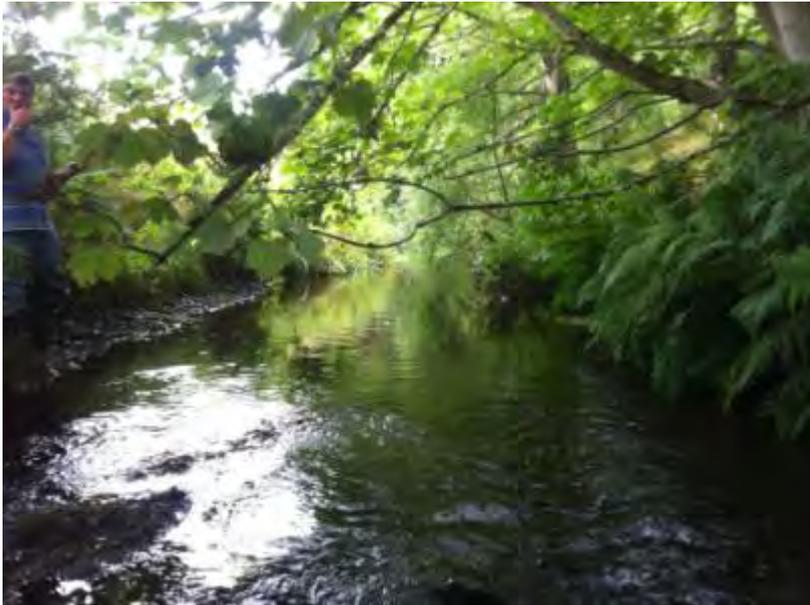
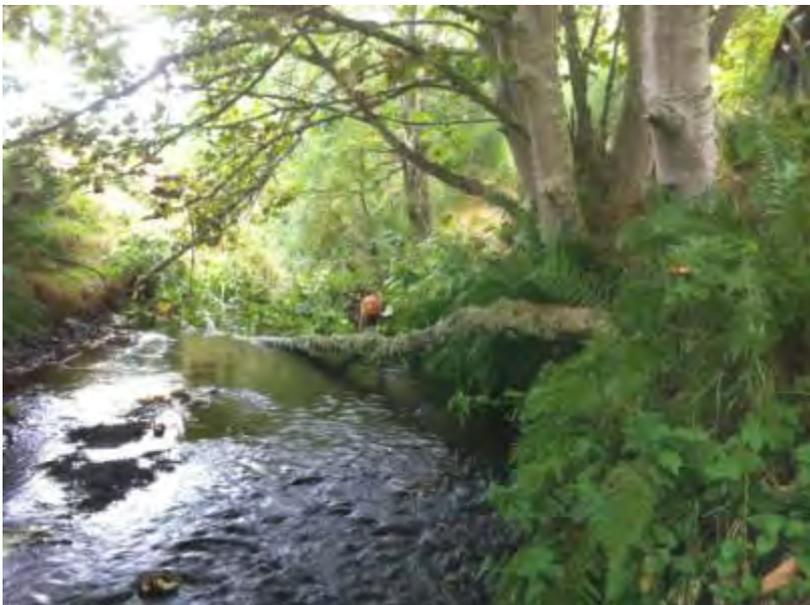
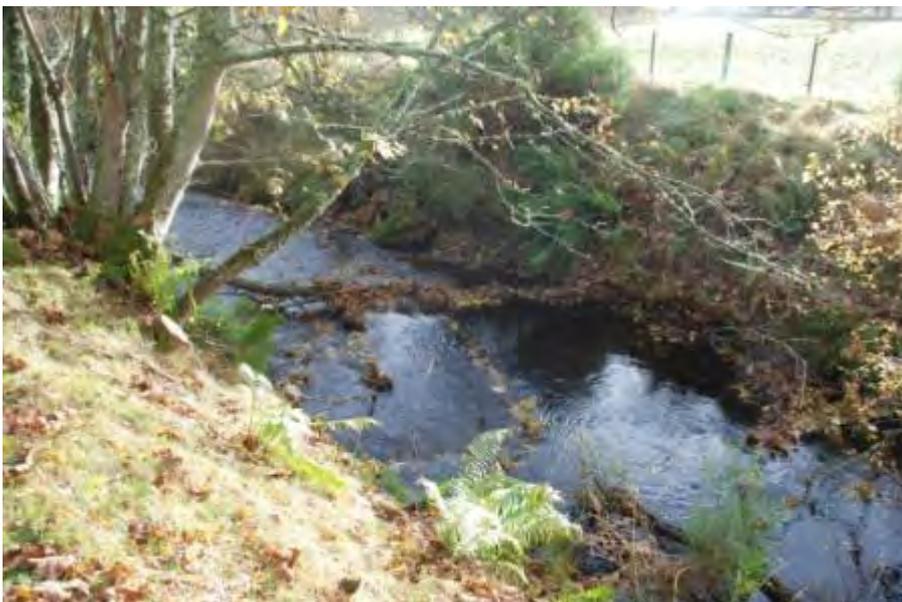
Site P4 (251716, 859465)

Pre works

During works

Post works

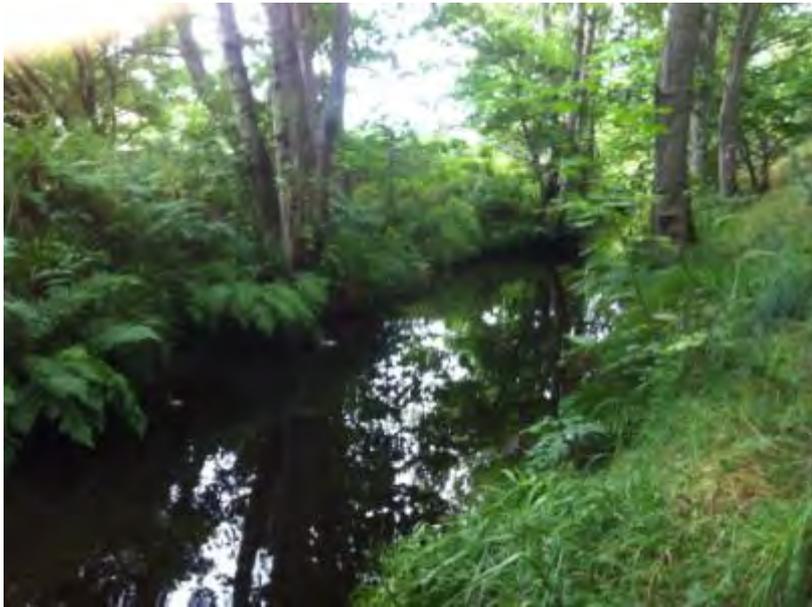
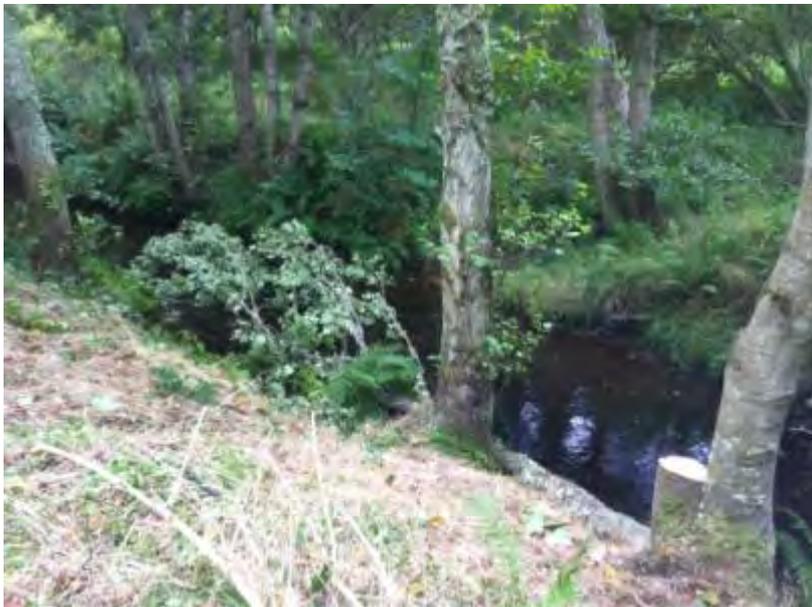
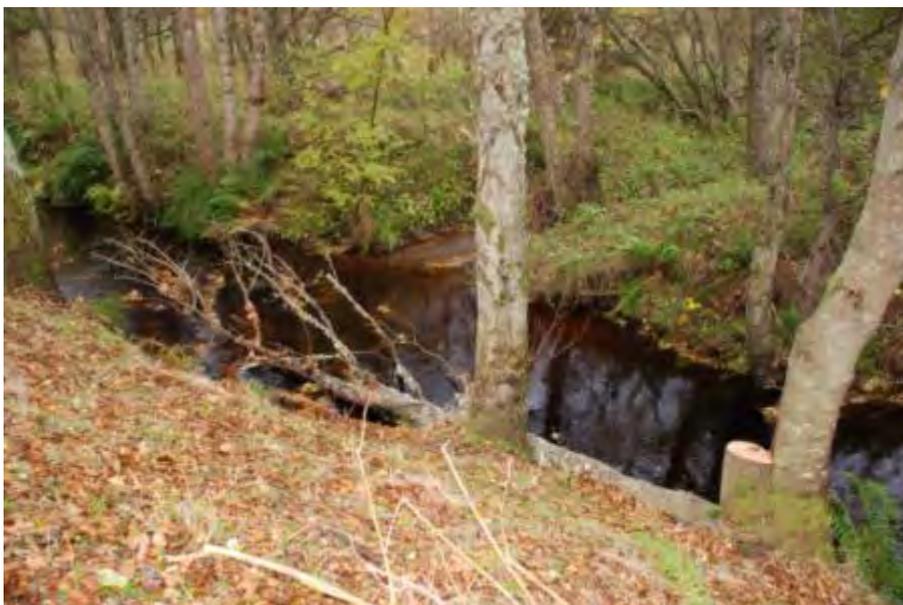
Site P5 (251778, 859458)

Pre works

During works

Post works
