The River Peffery Restoration Project

PHASE TWO, 2012

Marcus Walters of the Moray Firth Sea Trout Project reports

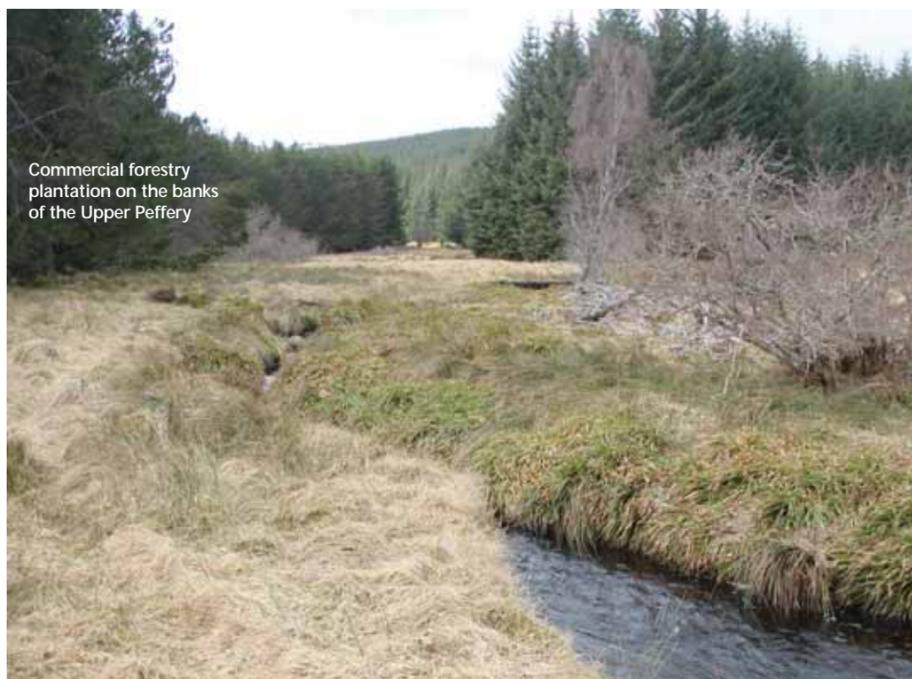
Commercial forestry plantation on the banks of the Upper Peffery

The upper half of the River Peffery (above Achterneed) drains the slopes of Ben Wyvis through an area of intensive coniferous plantation owned by the Forestry Commission Scotland. The Cromarty Firth Fisheries Trust is negotiating with the Forestry Commission to block forestry drains that are a source of fine sediment and to pull back conifers creating a buffer strip and increasing the space along the banks. In 2012 the Forestry Commission provided native saplings that CFDSFB staff, funded by SEPA Water Environment Fund, planted along the banks to act as a buffer strip from the commercial conifers. These works will help reduce sediment and acidic runoff into the Peffery. Reduced crowding and shading, augmented with planting, will allow native vegetation and trees to regenerate, stabilising river banks, increasing organic inputs (native leaf litter) and creating better habitat and species diversity.

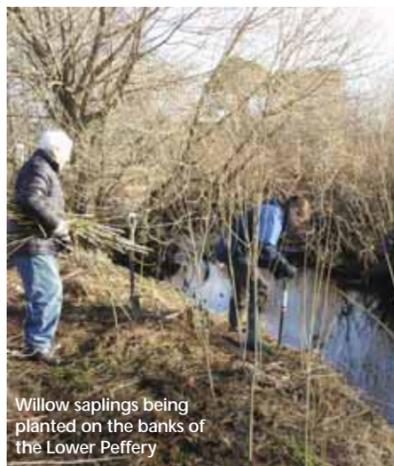
Willow saplings being planted on the banks of the Lower Peffery

Due to historical land management practices, much of the riparian zone has been left without native bank-side tree cover. Furthermore INNS have crowded out native species leaving, following treatment, large areas of bare and unstable banks. Funding secured by the MFSTP and CFFT from the SEPA Water Environment Fund has enabled DEG volunteers and TCV teams to plant extensive areas of Peffery banks with local willow cuttings and alder saplings. 3,000 willow cuttings were planted in 2012 and more planting went ahead in the winter of 2013.

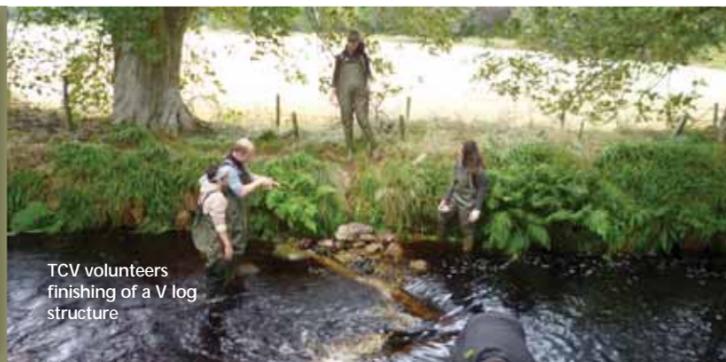
TCV volunteers finishing of a V log structure

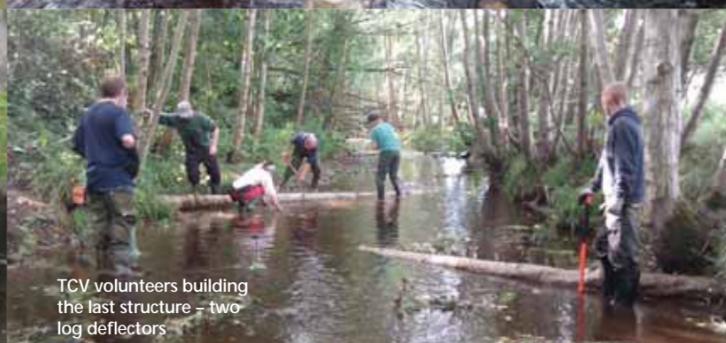
TCV volunteers building the last structure - two log deflectors

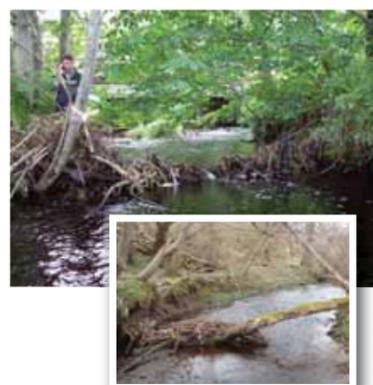
Naturally occurring large woody debris (LWD) in the Peffery. The in-stream structures are imitating the LWD helping the river to regain some natural processes and improve habitat while ensuring there is no risk of flooding or bank erosion

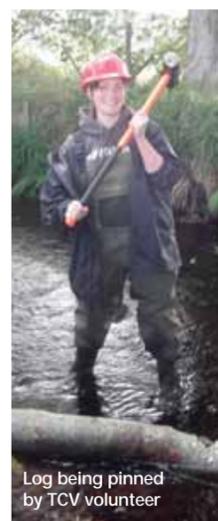
Log being pinned by TCV volunteer

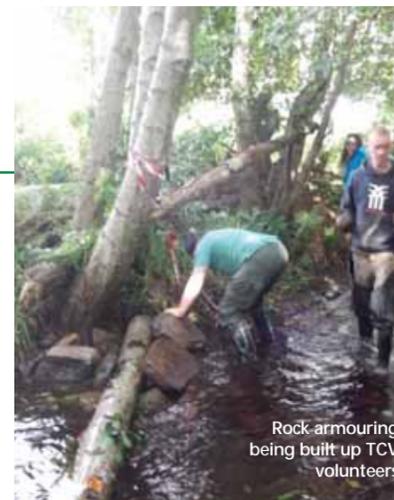
Rock armouring being built up TCV volunteers

- Logs are pinned in at bed level so they do not cause a flood risk or impoundment.
- End of log in the middle of river is set lower than the end in river bank to focus flow in middle and maintain low flow depth in centre of river.
- Rock armouring built up around log and against bank to stop erosion and focus flow in centre of channel.
- Armouring maintained low enough to ensure flood flow can pass over without impediment.

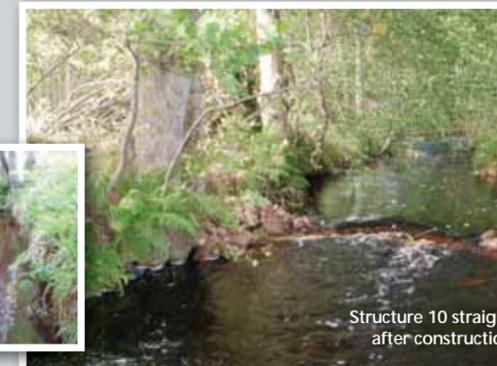
STRUCTURE 10
METRES FROM BRIDGE: 25
TYPE OF STRUCTURE:
Paired V-logs (Diagram A)

Structure 10 straight after construction
